# A Case Study on Failure of Anti-tank Missile Components

Sustainable Manufacturing and  
Foundry Practices  
1(2) 133–147, 2026  
© The Author(s) 2026  
DOI: 10.1177/IIIF.261485422  
Journal.indianfoundry.org

The pyro housings of the propulsion systems of three different anti-tank missiles were damaged during flight testing and received in damaged condition. Failure investigations were undertaken with the help of visual observation, optical microscopy, scanning electron microscopy, hardness testing, glow discharge optical spectroscopy, and optical emission spectroscopy to assess the reason for the failure of these components. Results indicated that all pyro housings were made from Al alloy HF15 grade (24345) and used in T6 heat-treated condition. The pyro housing of one missile failed, as the groove was longer and had a higher angle of inclination. This makes the groove thinner with reduced load-bearing capacity. There was improper manufacturing by closed-die forging of the other two pyro housings. This resulted in elongated grains in certain directions and lower load-bearing capacities. There was no metallurgical deviation from the recommended material and composition.

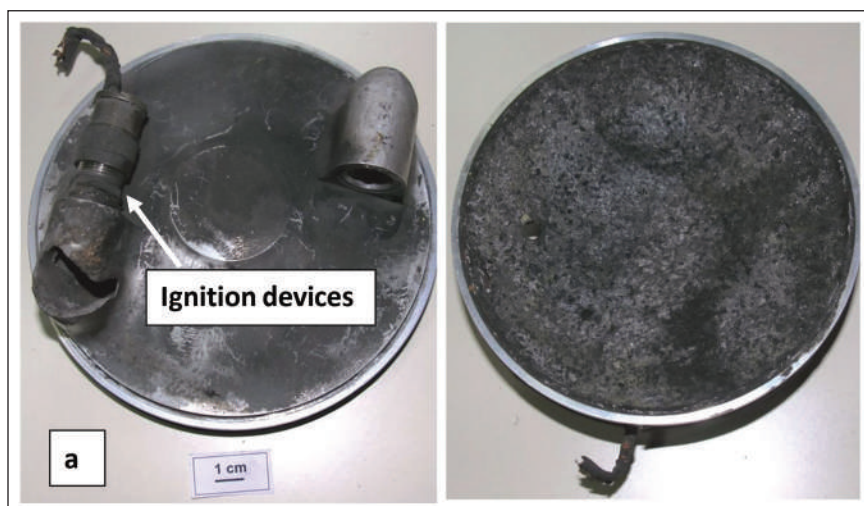
The failed booster head end of the pyro housing (PH-1) in the as-received condition is shown in Figure 1. Damage was observed to be due to an opening that occurred on the pyro housing where the pyro cartridge is fitted with an M16 threaded joint. Photographs showing the damaged, failed pyro housing, and intact pyro housing are presented in Figure 2. It is seen from Figure 2 that the damaged surface is very rough. The presence of several particles which solidified subsequently on the damaged surface can be

**Figure 1.** The Failed Booster Head End of the Pyro Housing (PH-1) (a) Front and (b) Back in the As-received Condition.

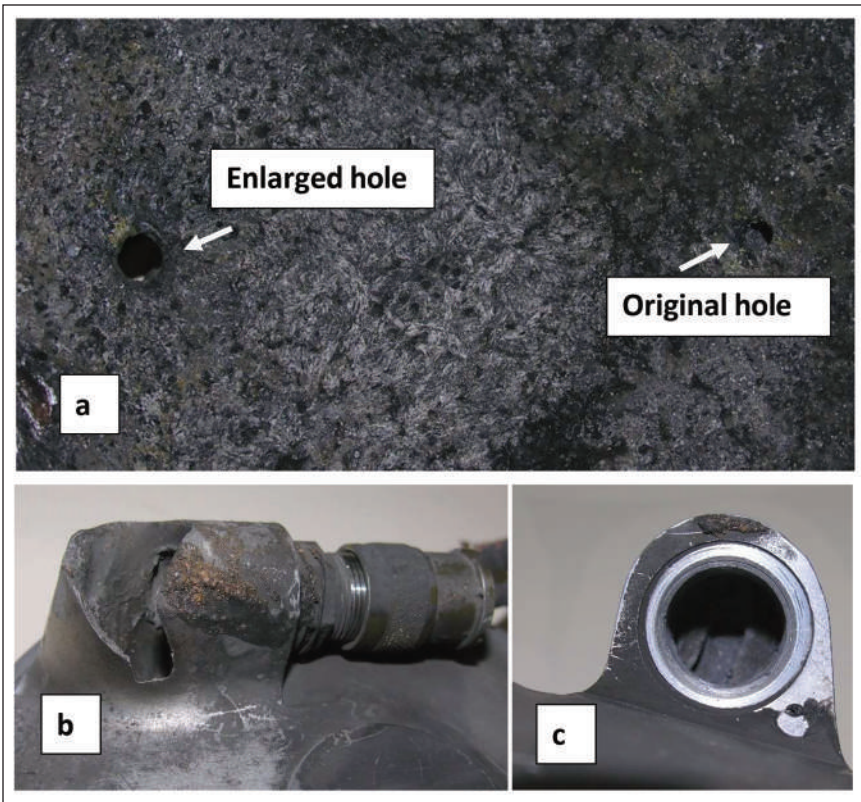
**Figure 2.** Photographs Showing the (a) Damaged Surface, (b) Failed Pyro Housing, and (c) Intact Pyro Housing.

surface to the outer surface of the housing. From the visual observations, it is seen that the pyro hole and the angle at which the groove is made are not the same in both pyro housings. The failed pyro housing has a more inclined angle and a longer groove length when compared to the other pyro housing, which is intact. This longer groove might have resulted in a reduction of the thickness of the housing. The reduction in thickness of the housing (PH-1) and the more inclined angle of the groove could not withstand the pressure developed during ignition. This results in the generation of subsurface and surface cracks, leading to the failure of the housing. The crack initiated at the triple point of the elongated grain boundary, which has significant segregation. A crack can be initiated at the interface of the undissolved precipitate and the matrix. These features are observed in the micrographs of the component (Figure 7). The elongated grains of the failed part indicate tensile stress in the direction of grain elongation. Surface cracks, which are also responsible for failure, are seen in Figure 6. Cracks are generated on the surface as the stresses are maximum on the surface.

3. Metallurgical abnormality related to deviation from recommended material and composition or heat treatment cannot be noted.
4. The angle at which the groove is made is higher, and the grooves are deeper in the case of failed pyro housing than in the case of the pyro housing that was intact. This leads to a reduction in thickness and an increase in stresses, which, in turn, is responsible for the failure of the pyro housing (PH-1).

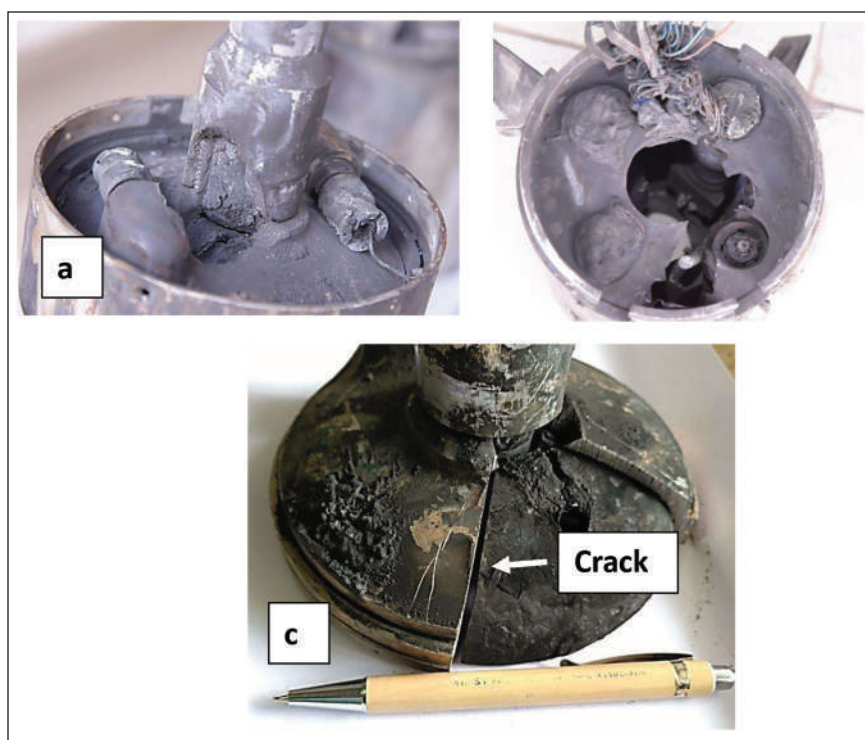
noted. It is also noted that one hole is larger than the other one. The images of the damaged pyro housing (PH-2) of another anti-tank missile are presented in Figure 3. A part of the dome was found to be melted (Figure 3(a)). The rear wall was broken (Figure 3(b)), and the central hub was facing the pyro; with the loss of dome surface backing, the inner composite liner developed a crack (Figure 3(c)). The liner hole enlarged, and a crack was found to form in the liner hole. The photographs of the failed pyro housing of the third missile are illustrated in Figure 4. The liner is removed from the dome. Some deposition of molten metal can also be seen. Deposition of molten aluminium metal is shown in Figure 4. Part of the aluminium alloy casing of the blast tube melted (Figure 4(c)). The end wall of the flight is damaged (Figure 4(d)). A crack can be seen on the liner as well (Figure 4(e)).

**Figure 3.** The Images of Damaged Pyro Housing (PH-2). (a) Failed Dome, (b) Broken Rear Wall, and (c) the Liner.

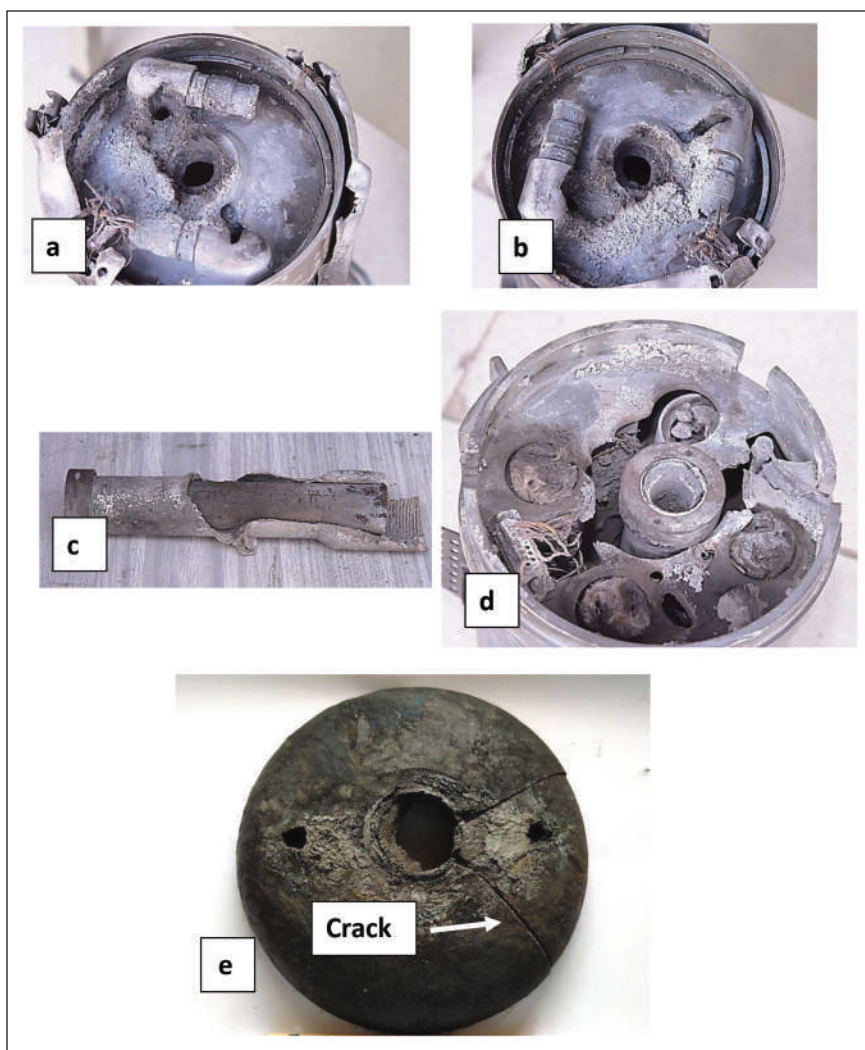
**Figure 4.** The Photographs of Both Failed Pyro Housings of PH-3, (a) and (b) Damaged Dome, (c) Casing of Blast Tube, (d) Broken End Wall, and (e) the Liner.

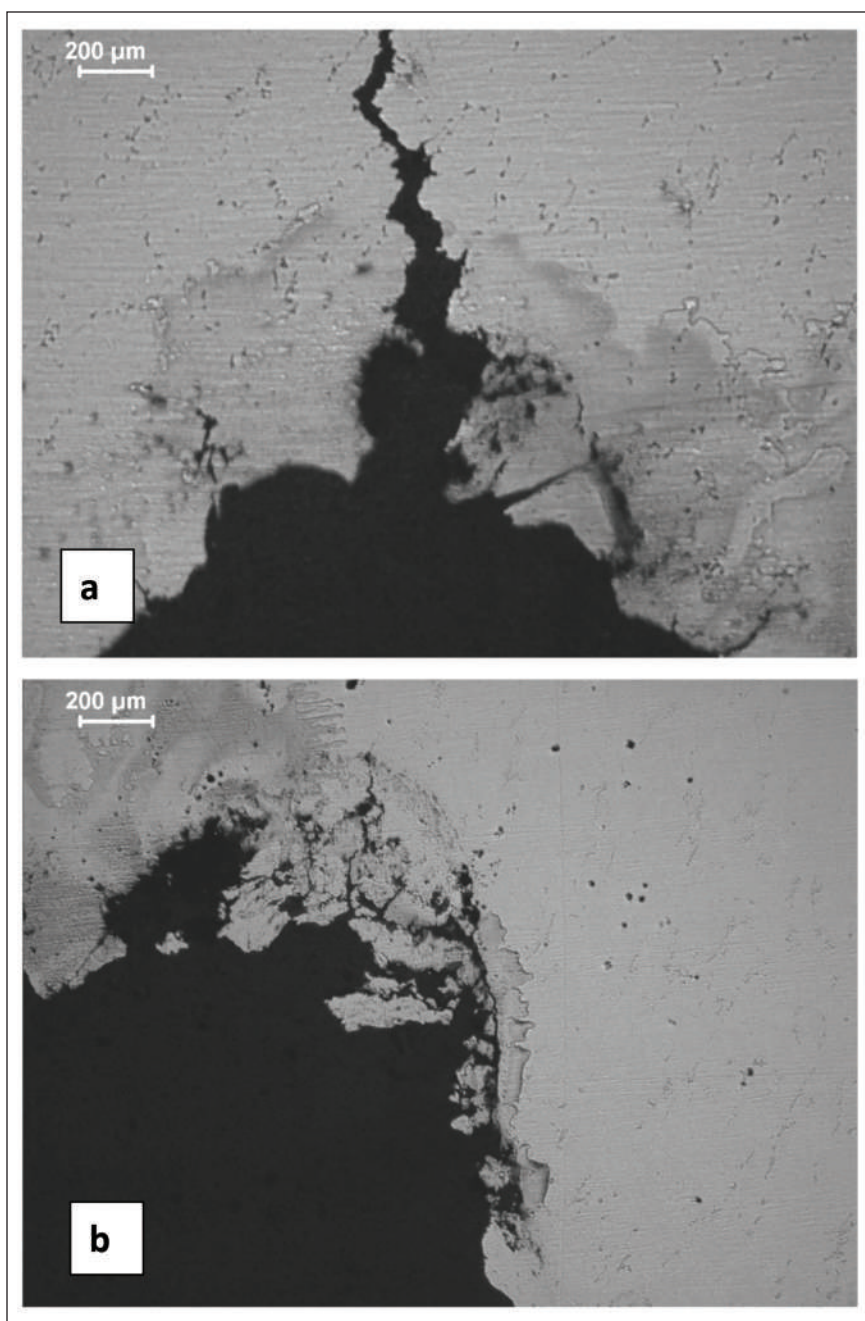
**Figure 6.** Optical Micrograph of PH-I in Unetched Condition Showing Cracks Emanating from the Fracture Surface.

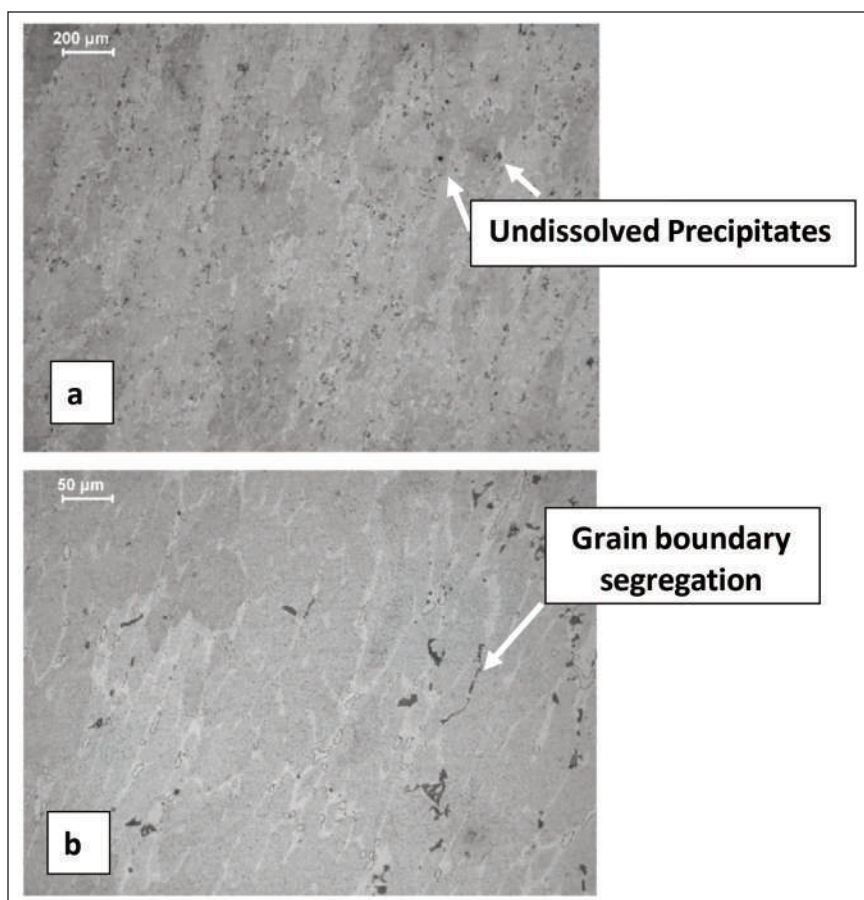
**Figure 7.** The Optical Microstructures Prepared from Heat-affected Zones of PH-1.

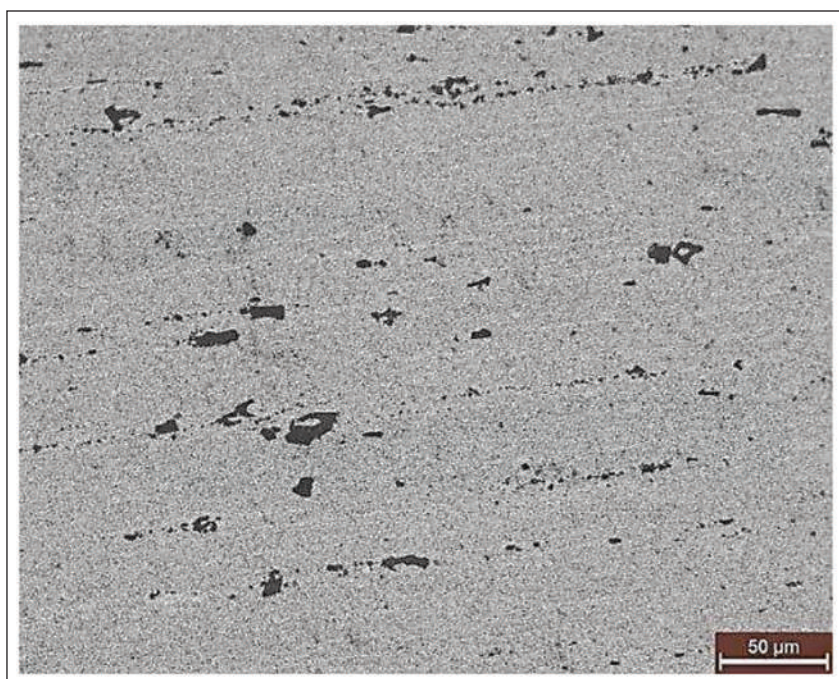
**Figure 8.** The Optical Microstructures Prepared from Heat-affected Zones of PH-2.

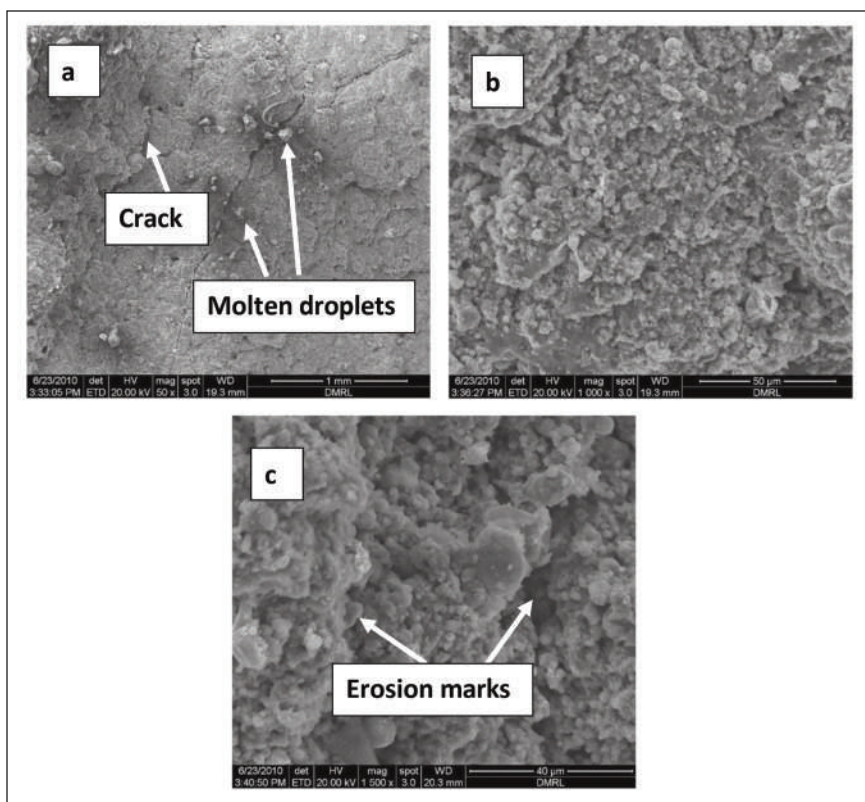
The failed sample was cut carefully not to damage the fracture features and ultrasonically cleaned in acetone. The scanning electron microscopy (SEM) fractography of PH-1 given in Figure 10 has shown eroded features with oxide coating. One fine crack is also observed on the fracture surface (Figure 10(a)). SEM micrographs of the failed surfaces of PH-2 and PH-3 are presented in Figure 11. Deposition of molten metal in some places can be noticed. Figure 11 also reveals a clean-cut area possibly obtained by gas cutting.

**Figure 10.** (a, b, c) Scanning Electron Microscopy (SEM) Fractograph Taken from the Failed Surfaces of PH-I.

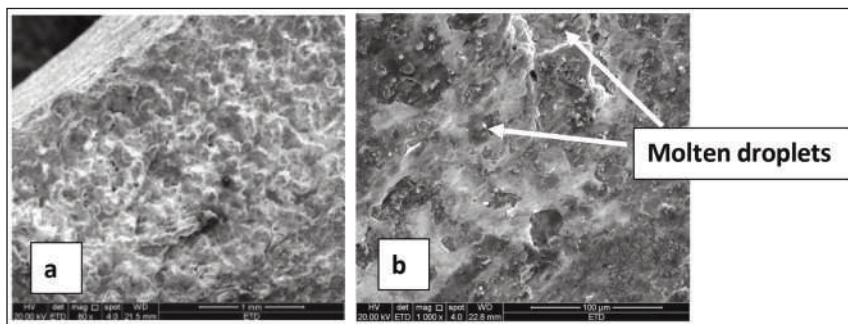
The failed parts of PH-2 and PH-3 are made of aluminium alloy similar to that of PH-1, as revealed by composition analysis. The chemical composition, microstructure, and hardness are well within the specified range, as seen above. Therefore, material deficiency is ruled out as the cause of the failure. Signs of hot gas flowing between the liner and the aluminium dome can clearly be understood, as failed parts have features of damage by hot gas. This exposure to the super-hot gas might raise the temperature of the dome, causing loss of strength and subsequent failure of the pyro housing wall. Evidence of pyro housing (PH-2 and PH-3) leaking was noted. The hot gases are directed toward the blast tube of PH-2, resulting in the melting away of part of the dome and central hub facing the pyro, with the loss of dome surface backing; the inner composite liner developed a crack. The hot gases escaped from the last chamber by breaking the rear wall. The gas flow of PH-3 was directed toward the centre, melting away the aluminium alloy casing of the blast tube on one side up to half of the length. A small part of the dome surface was melted. The hot, high-speed gases made some holes in the rear wall of the last chamber and escaped. Some molten aluminium metal is seen deposited. The liner of PH-3 showed a pattern of gas flow from the pyro holes toward the centre. This flow occurred between the aluminium alloy dome and the composite liner. The leak was initially directed horizontally toward the centre and then became vertical due to erosion in the aluminium alloy wall. The quantum of gas flow in PH-3 is significantly higher than that in PH-2, resulting in alteration of the microstructure of PH-3 but not in PH-2. The gas flow left evidence of deposition of molten Al alloy, and higher gas flow in PH-3 gives rise to a clean gas-cut surface.

**Figure 11.** Scanning Electron Microscopy (SEM) Micrographs of the Failed Surfaces of (a) PH-2 and (b) PH-3.
