# A Case Study on Failure of Anti-tank Missile Components

Sustainable Manufacturing and  
Foundry Practices  
1(2) 133–147, 2026  
© The Author(s) 2026  
DOI: 10.1177/IIIF.261485422  
Journal.indianfoundry.org

The pyro housings of the propulsion systems of three different anti-tank missiles were damaged during flight testing and received in damaged condition. Failure investigations were undertaken with the help of visual observation, optical microscopy, scanning electron microscopy, hardness testing, glow discharge optical spectroscopy, and optical emission spectroscopy to assess the reason for the failure of these components. Results indicated that all pyro housings were made from Al alloy HF15 grade (24345) and used in T6 heat-treated condition. The pyro housing of one missile failed, as the groove was longer and had a higher angle of inclination. This makes the groove thinner with reduced load-bearing capacity. There was improper manufacturing by closed-die forging of the other two pyro housings. This resulted in elongated grains in certain directions and lower load-bearing capacities. There was no metallurgical deviation from the recommended material and composition.

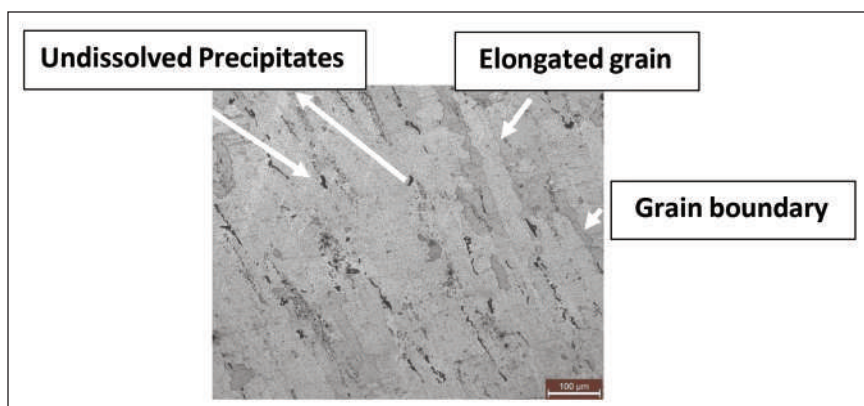
A representative microstructure of the metallic part of an intact pyro housing is provided in Figure 5. The material appears to be in solutionized, quenched, and

aged condition. Al alloys, based on their composition, are solution treated between 500 °C and 550 °C for a few hours so that strengthening elements are fully dissolved in the matrix. This is followed by rapid quenching in water so as to make a supersaturated, unstable solid solution. Finally, the part is artificially aged between 150 °C and 180 °C to precipitate the hardening particles. This treatment results in an increase in strength and hardness. This treatment is referred to as 'T6 heat treatment' for Al alloys. In the unetched condition, the microstructure of PH-1 indicates the presence of a crack that was propagating from the fracture surface toward the inside, as illustrated in Figure 6. An optical micrograph of damaged parts of PH-1 is given in Figure 7. Figure 7 reveals that, on etching with Keller's reagent, the microstructure reveals elongated grains and undissolved precipitates. Microstructures prepared from heat-affected zones of PH-2 and PH-3 are illustrated in Figure 8 and Figure 9, respectively. Although the heat-affected zone of PH-2 retained the original structure as shown in Figure 8, the microstructure of the heat-affected zone of PH-3 indicates grain boundary segregation and a rosette structure (Figure 9). These features confirm incipient melting of the material of PH-3.

**Figure 5.** A Representative Microstructure of the Metallic Part of an Intact Pyro Housing.
